DELAWARE RIVER BASIN
YORK CREEK, PIKE COUNTY
PENNSYLVANIA

ELM LAKE DAM

PHASE I INSPECTION REPORT
NATIONAL DAM INSPECTION PROGRAM

NDI - PA 00397
PA DER 52 - 164

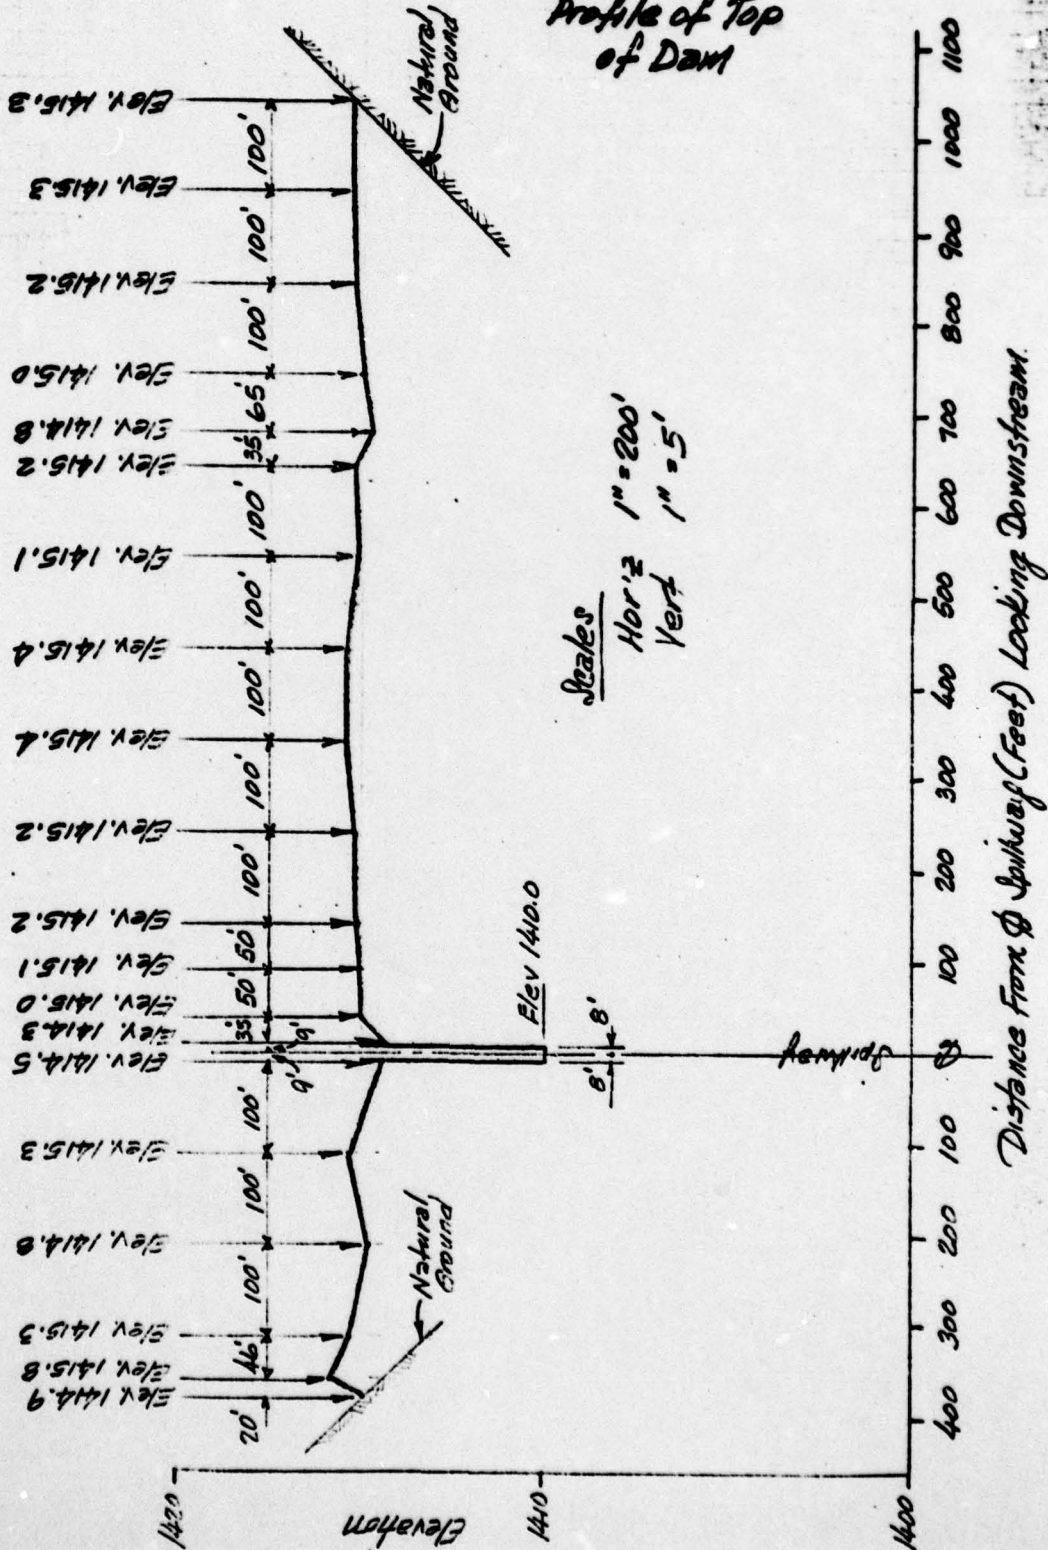
PLATE 5
Profile of Top
of Dam

Based on visual observations made during the date of inspection, the dam is considered to be in fair condition. However, the uneven nature of the surface along the top of dam is indicative of settlement or poor construction methods. The embankment should be monitored periodically to detect signs of differential movement.
